WRDC-TR-89-4055

COMPENDIUM OF FRACTOGRAPHIC DATA FOR COMPOSITE  
MATERIALS

INTERIM REPORT  
Covering 9-22-86 through 10-31-88

C. Hua  
M. Yamashita  
Boeing Advanced Systems  
P.O. Box 3707  
Seattle, WA 98124

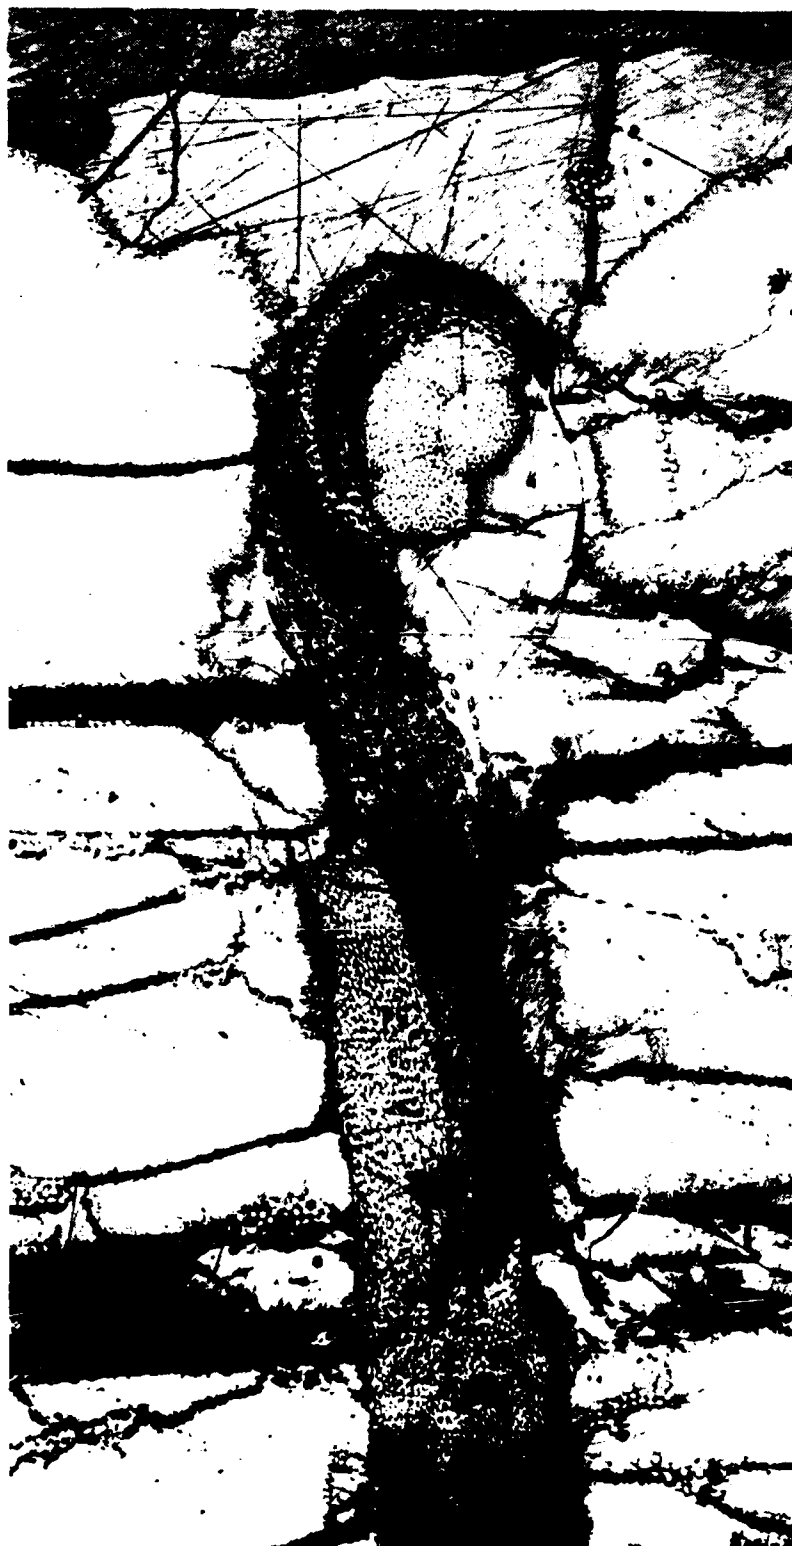
*Figure 4.4-86. Damage Around Kevlar 29 Stitch*

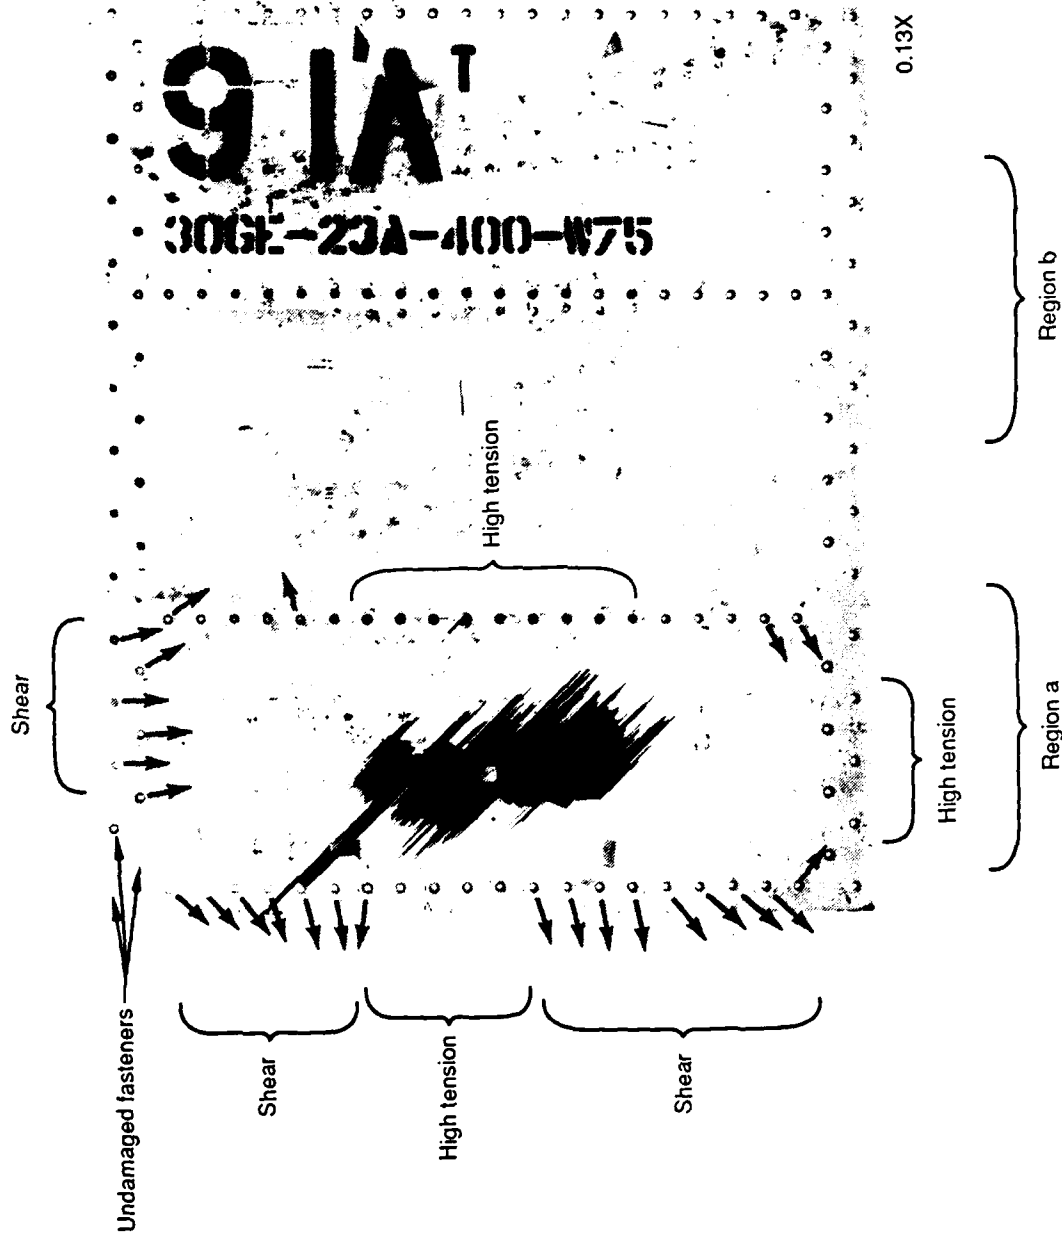
Figure 7.4-5. Mapping of the Fastener Hole Damage

In conjunction with stress analysis, visual examination was performed using fastener hole damage as evidence to determine the loading condition experienced by the panel during the test. The key evidence was the depth and elongation of the hole. In general, hole elongation indicates shear-type loading in which the head and the shank of the fastener tilt at an angle to the hole. Figure 7.4-3 illustrates the damage of a typical shear loaded fastener hole. The damage seen in the countersunk region of the fastener

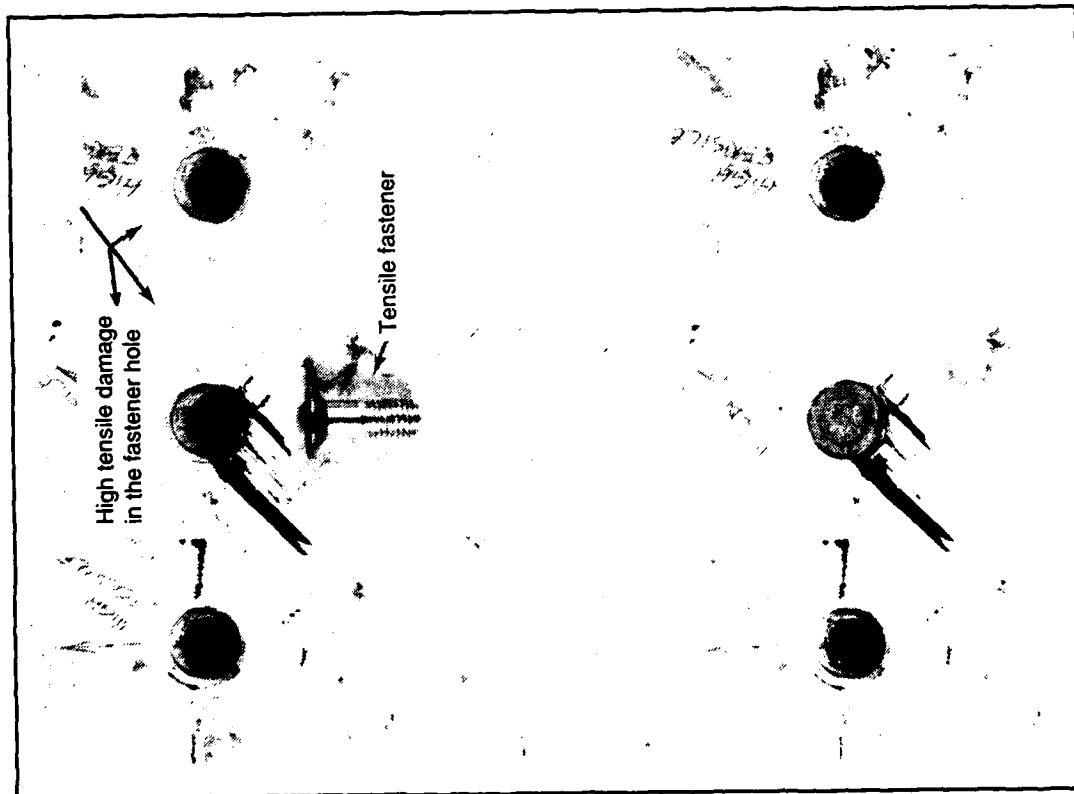
a. Tensile fastener (fits loosely in fastener hole)

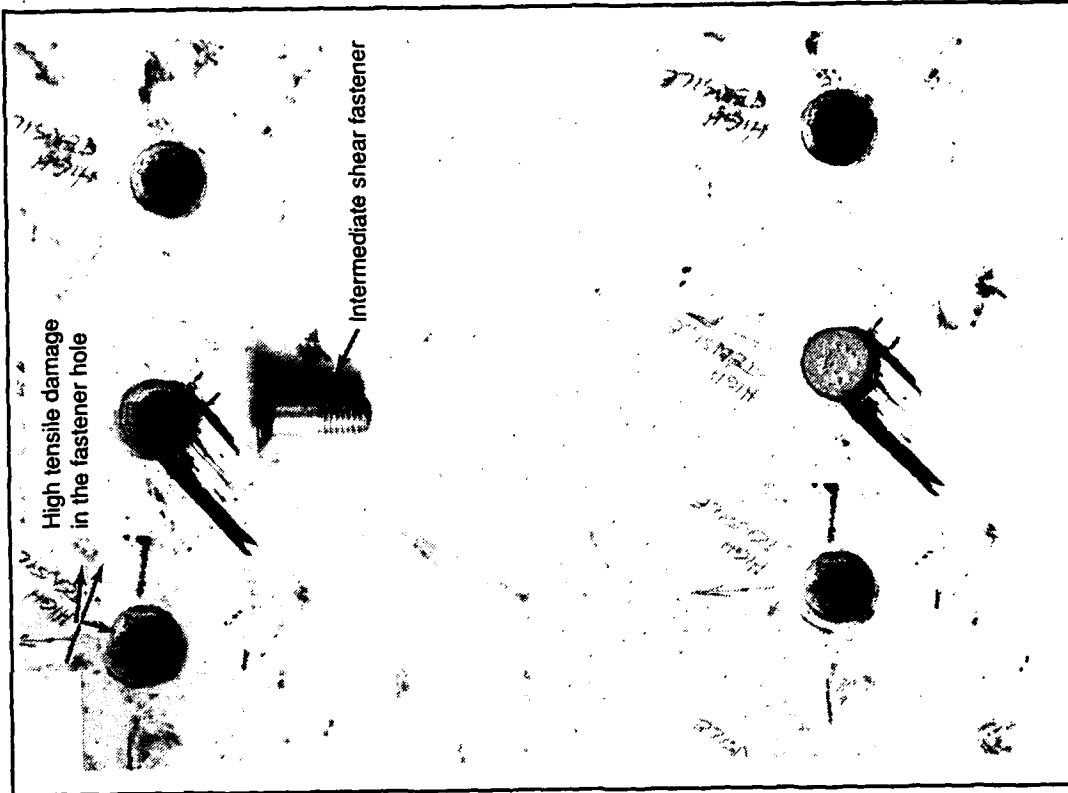
b. Shear (intermediate) fastener (fits snugly in fastener hole)

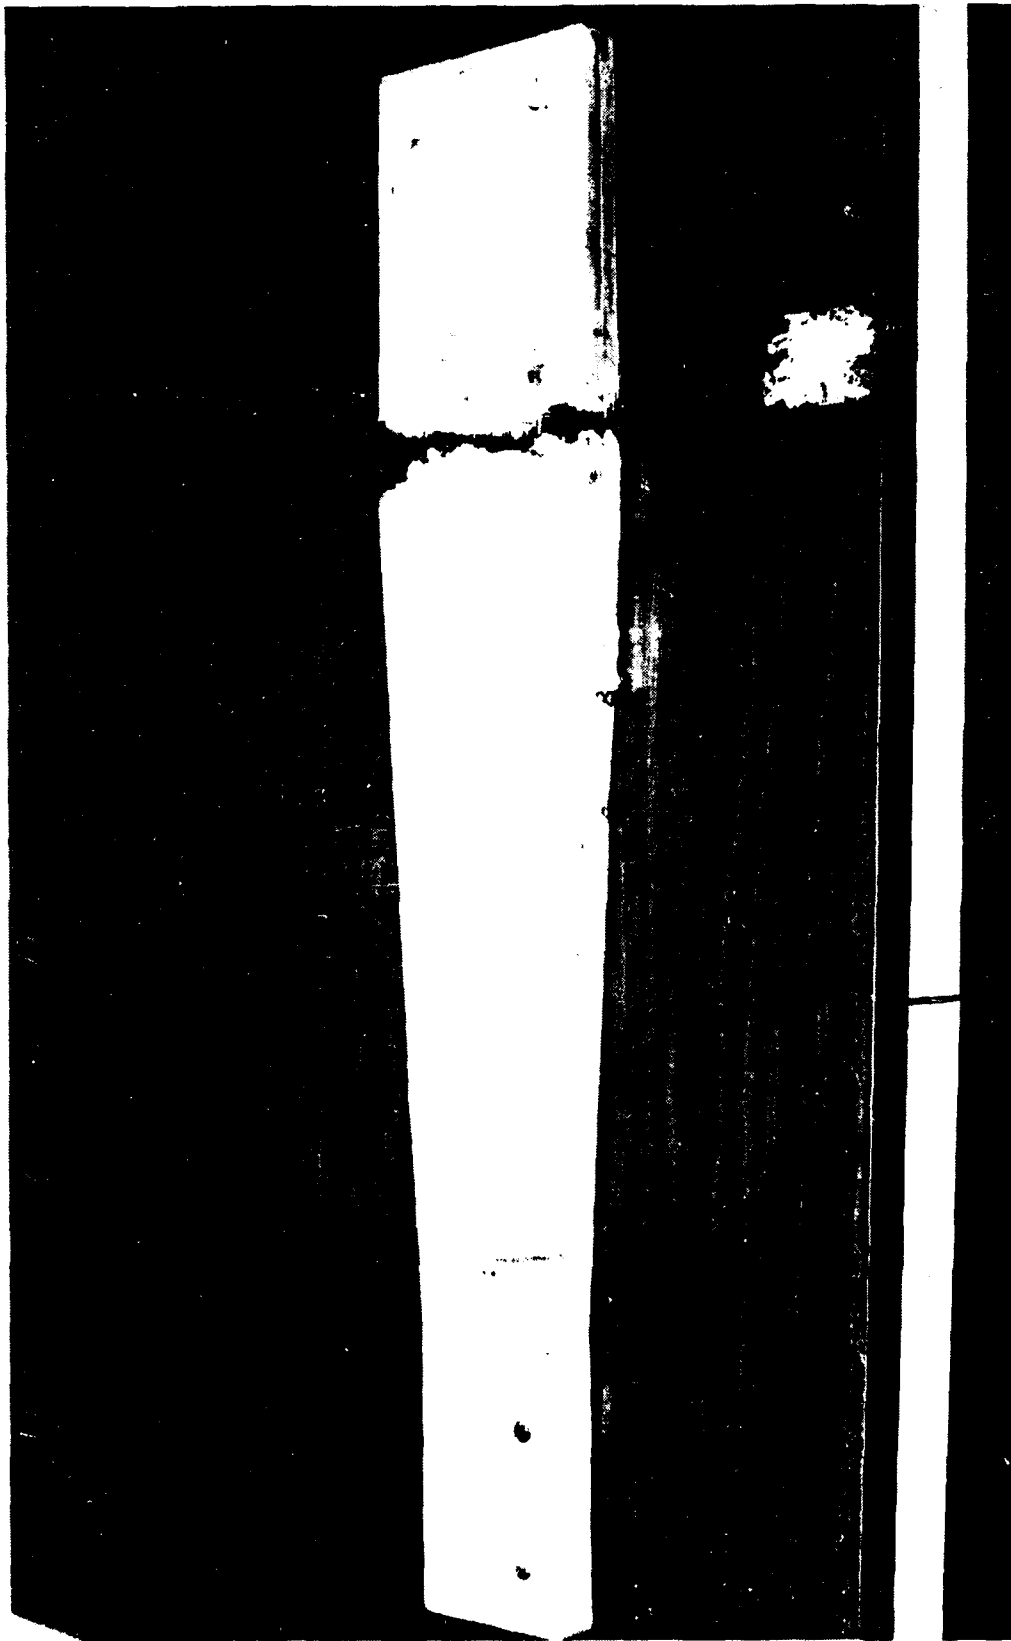
*Figure 7.4-16. Macro photograph of the Upper Surface of the Landing Strut as Received*

Upper surface

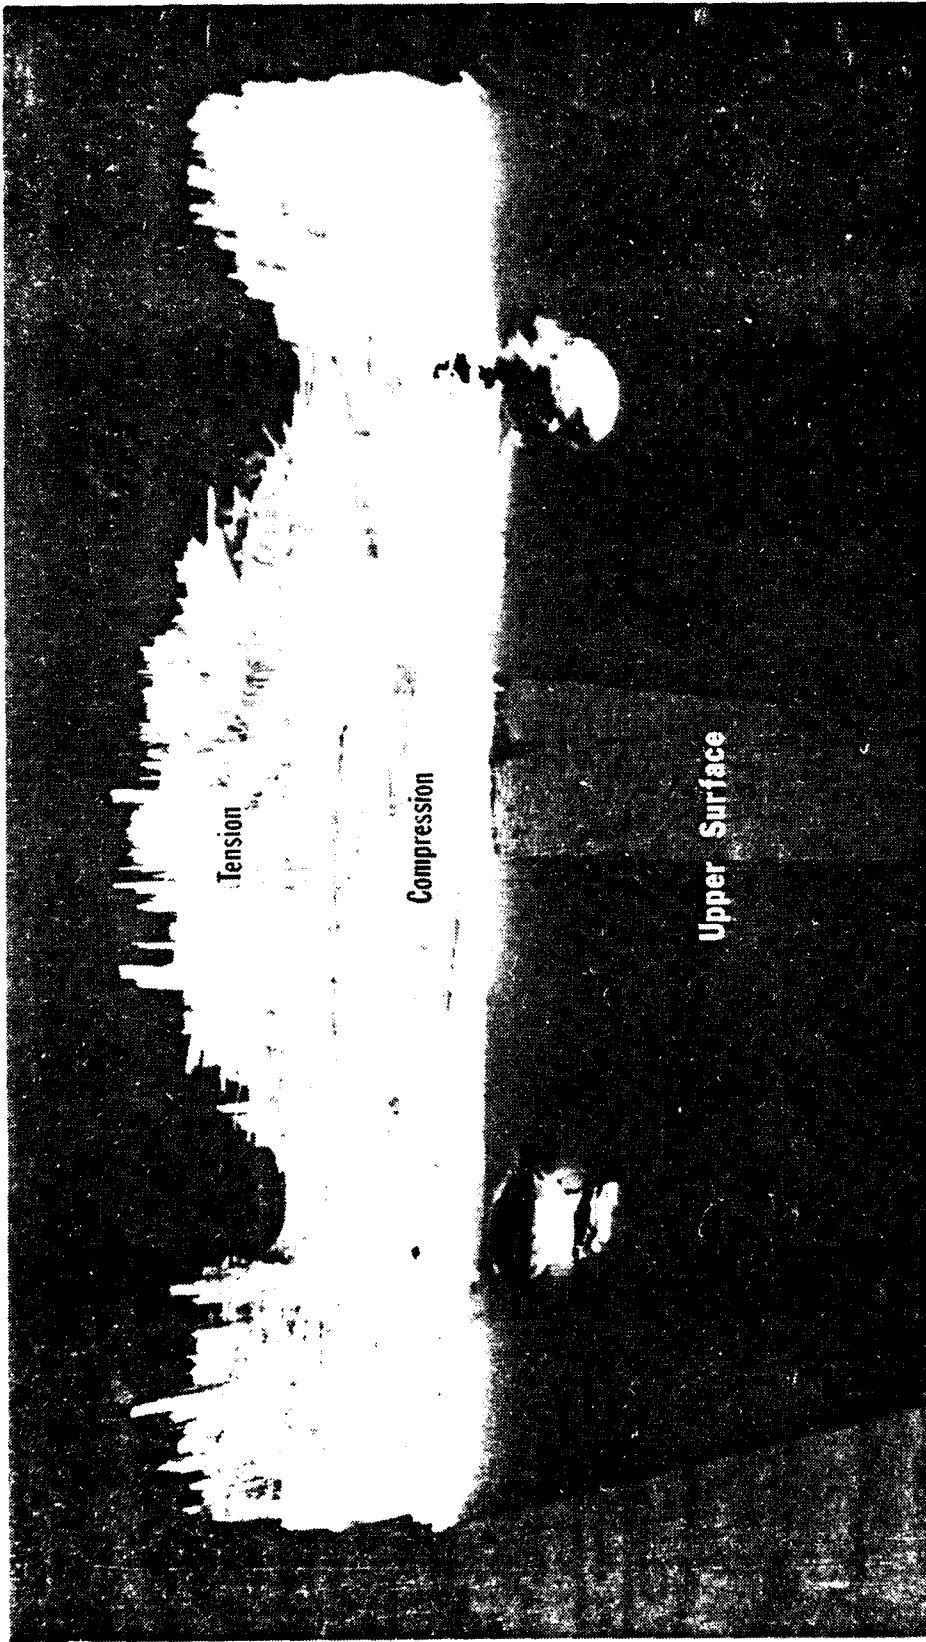
Figure 7.4-17. Macro photograph of the Translaminar Fracture Surface on the Small (Fixed Piece) of the Strut. Tension fracture is multiphase and shows individual fibers or bundles; compression fracture is planar.

Fracture surface—small piece

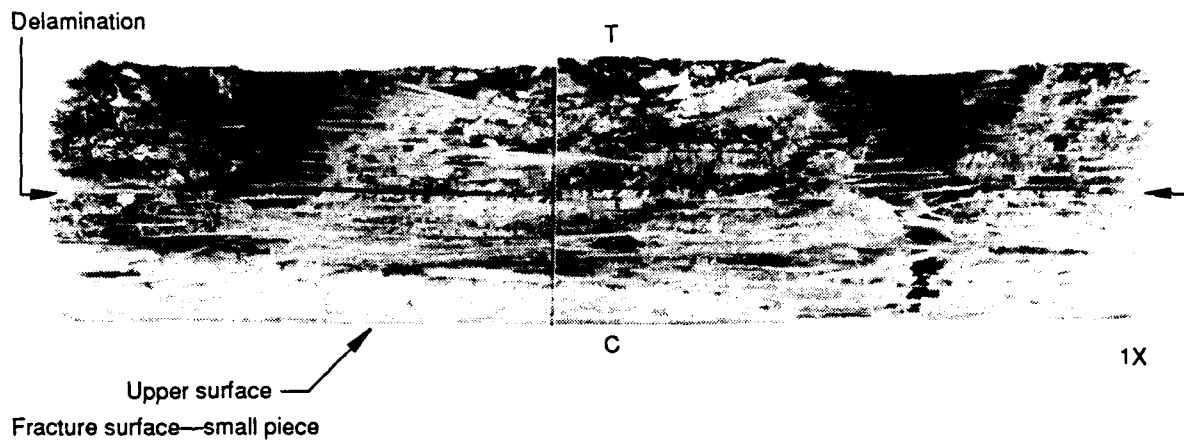
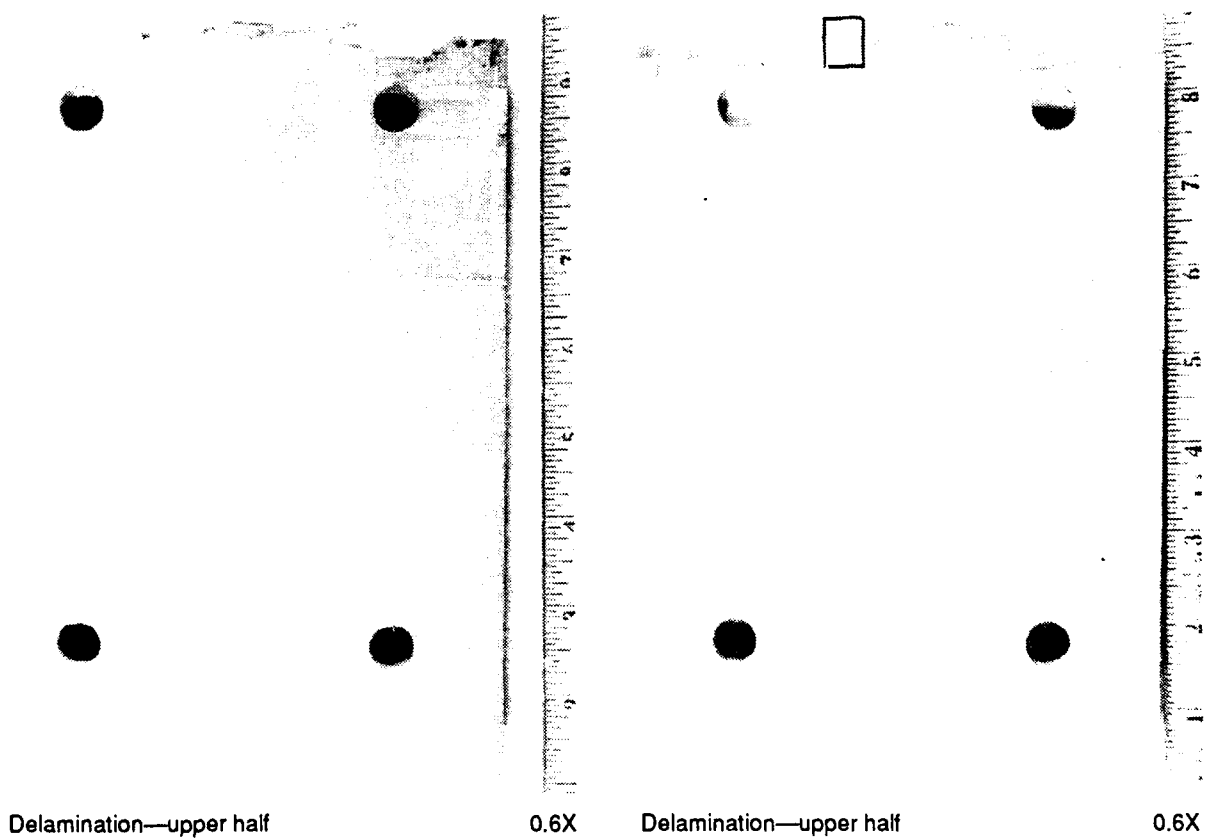
**Figure 7.4-18. Macrophotographs of the Top of the Small Piece Fracture Surface Showing Delamination, Upper Surface, Tension Fracture (T) and Compression Fracture (C). The lower macrophotographs show the mating delamination surfaces after laboratory separation of the delamination. The area shown by the small box is magnified in figure 7.4-24.**

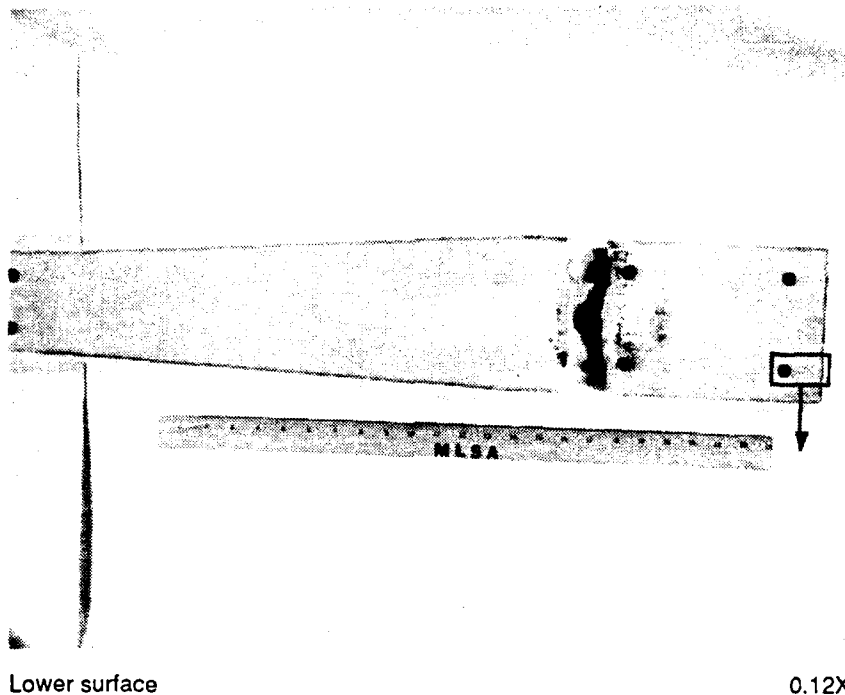
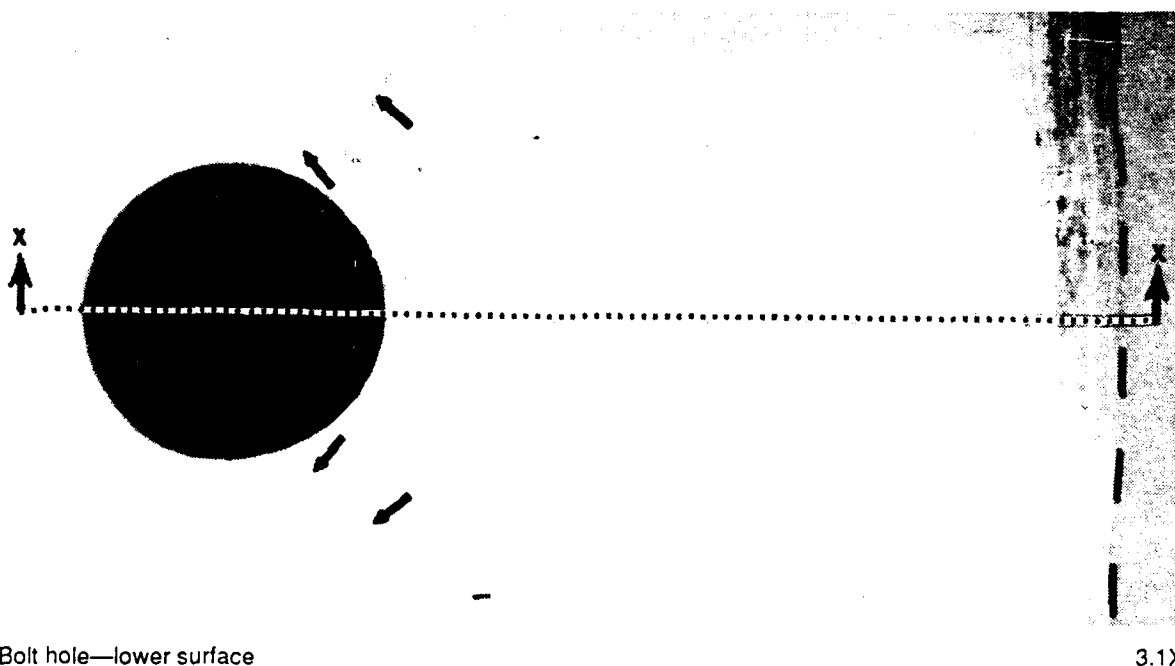
*Figure 7.4-22. Macrophotographs of the Lower Surface of Strut.* The figure shows the location and orientation of section x-x, magnified in figure 7.4-23. The local bulging at the end of the strut (emphasized by the segmented line) occurred as a result of restraint from the bolt. Cracks labeled by the small arrows were also generated by this loading condition.
